## PRODUCT EVALUATION 86-18 JOINT SEALANT STUDY

**Construction Report**

JOINT SEALANT STUDY
CONSTRUCTION REPORT

**JANUARY 7, 1987**

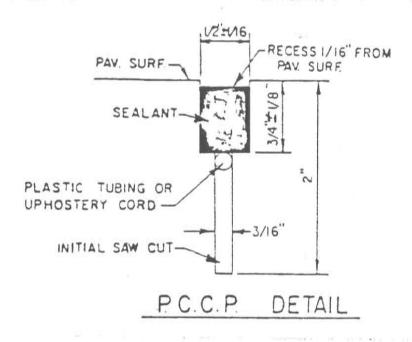
Figure 2- Original Pavement Joint Detail

The original project, I-17-2(35), was built in 1974. The eight inch thick, 24 foot wide slab, was constructed with eight inches of portland cement concrete pavement over six inches of portland cement treated base. Contraction joints were designed to be at 17, 15, 13, 15, 17 foot spacings. Actual spacings and current condition of the test section are documented in Appendix B. Joints are on a 6:1 skew with an original saw cut of 1/4 the pavement thickness (two inches). The original joint sealant material was Superseal 444. (Figure 21)

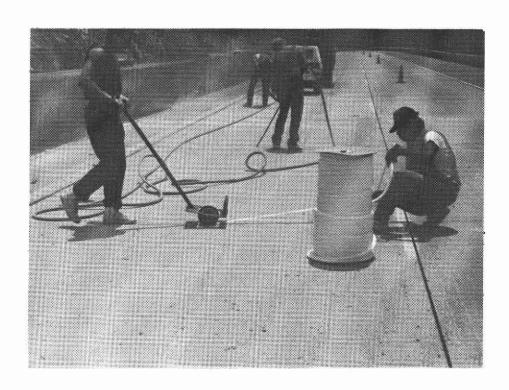
Figure 4- Placing Backer Rod

The placement of A, B, C, and E was performed by the contractor, Conseal of Layton, Utah. Material D was placed by Robert Rutherford, a field representative of Crafco, using a Crafco EZ Pour 50 Melter. All joints were sawed to a depth of 2 inches and a 1/2 inch nominal width by the contractor. Actual joint width was closer to 3/4 inches. All joints were sand blasted and air-blown by the contractor. (Figure 3) The backer rod was Hercules XL, a 7/8 inch closed cell polyethalene material. All joints utilized the same backer rod; however, different depths were used for different products. The backer rod was placed with steel wheels set to the necessary depth. (Figure 4)

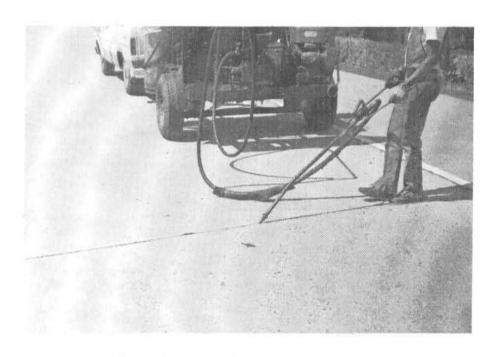
Figure 7 - Placing Hot-Pour Joint Sealant

The Allied-Koch 9005 exhibited a great deal of flow on the .052 foot per foot superelevated horizontal curve. Also, a large number of bubbles were observed immediately after placement. It was visually estimated that there were two to three bubbles per lineal inch.

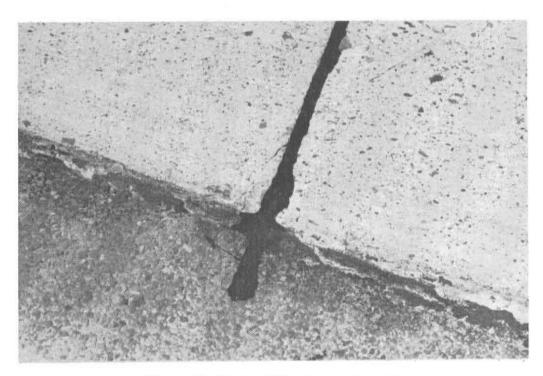
Figure 8 - Typical Hot-Pour Material

The material did not exhibit the same flow characteristics as the Allied-Koch 9005 and SOF-SEAL materials. The Roadsaver 231 material appeared stiffer and, therefore, a more uniform depth of sealant was evident in the superelevated portions of the curves. Air bubbles were present immediately after placement of the sealant - approximately three bubbles per lineal inch.
